Manhole Inspection Summary

Manhole # S25AA1016MH

Insp Date: **1/29/07 1:13 PM**

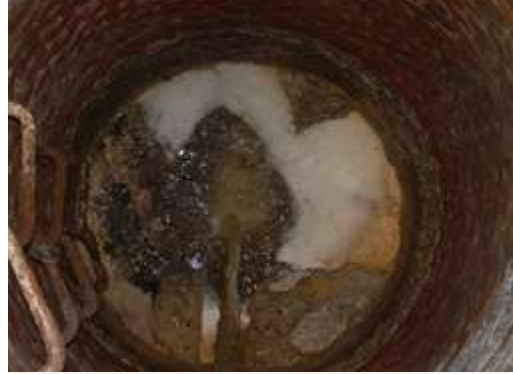
Top View

Corroded steps. Evidence of surcharge - Bench debris. Channel debris.

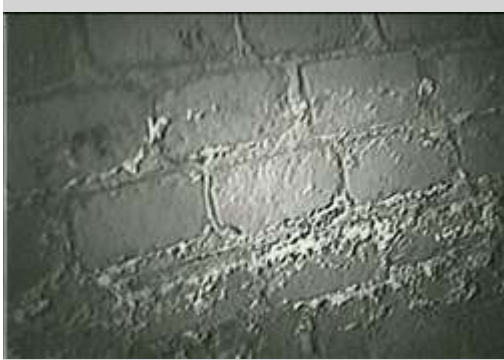
Defect

Evidence of surcharge.

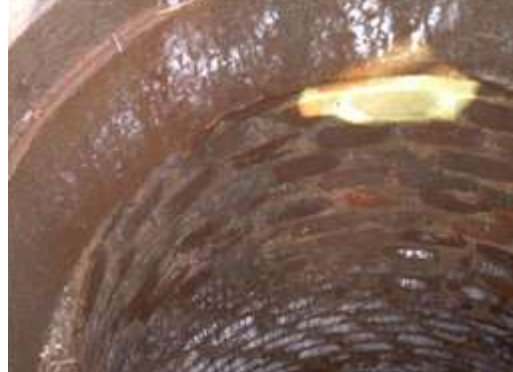
Defect

Frame leaks. Adjustment deterioration and infiltration.

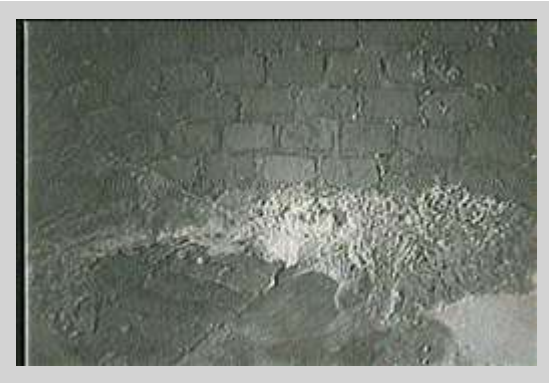
8 in. Circular Gravity Sewer Pipe Out @ 12 O'Clock

Invert Depth: **14.57** (ft.) Flow Characteristics: **Slow**

Infiltration: **None** Pipe Seal Cond: **Unknown**

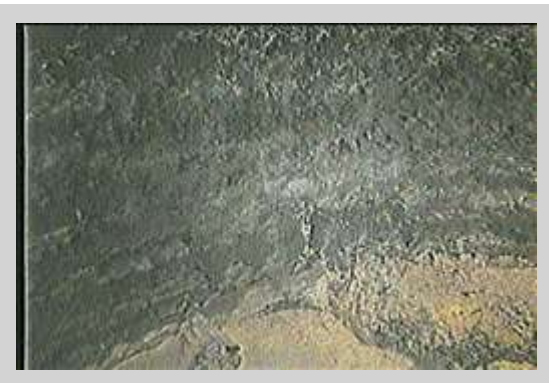
8 in. Circular Gravity Sewer Pipe In @ 3 O'Clock

Invert Depth: **14.41** (ft.) Flow Characteristics: **Slow**

Infiltration: **None** Pipe Seal Cond: **Unknown**

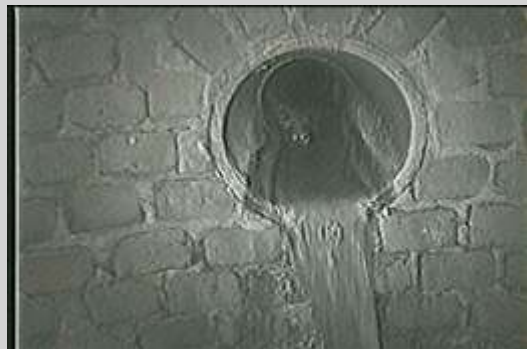
Pipe In @ 6 O'Clock

Invert Depth: **10.25** (ft.) Flow Characteristics: **Slow**

Infiltration: **Evidence**
